Setting The Stage

The scope of work in the bid seemed straightforward. American Restore was to rehab the orchestra pit the Greek Theater. The project was a part of a multimillion dollar upgrade to the historical icon located in Los Angeles' Griffith Park. The Greek Theater was constructed in 1928-1930. The scope had three key requirements: waterproof the deck, provide a smooth, trip-free, attractive surface, and complete the task during the venue's winter performance break.

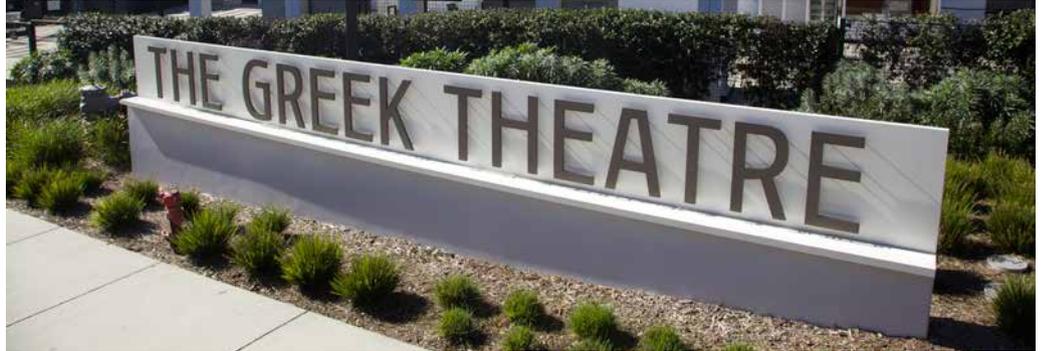
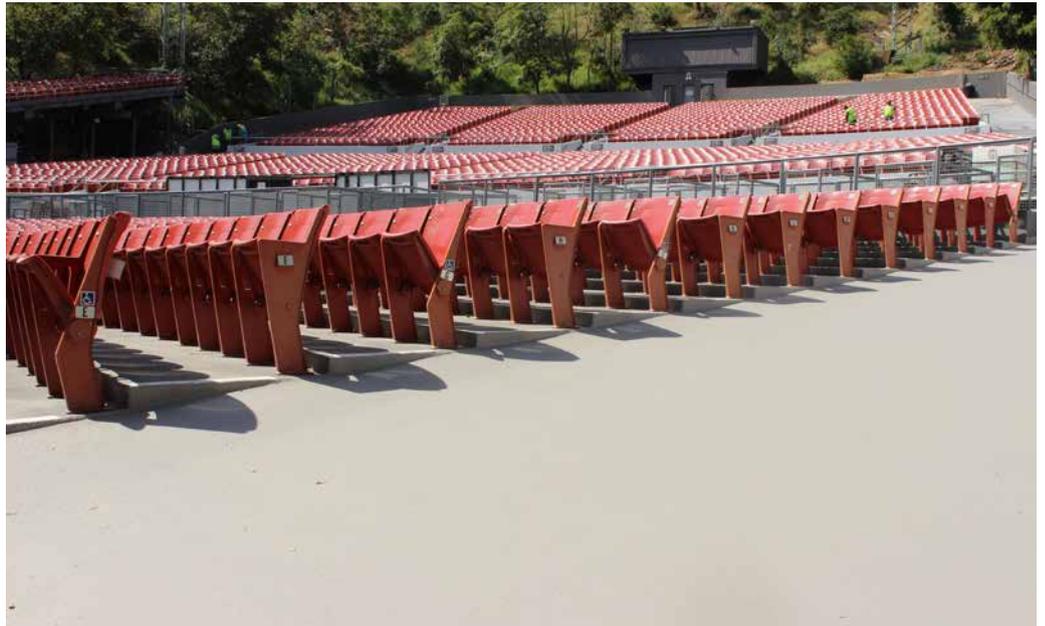
The orchestra deck appeared to be a solid slab. But after removing the pre-existing coating, the deck was actually two slabs. The lower slab had been placed during original construction. The upper slab may have been added either during the seismic upgrade, or as part of a previous repair.

A second surprise was the byzantine array of control joint and cracks. The repair to the cracks seemed straightforward. But Ball quickly assessed that waterproofing the cold joints from the original 1930 concrete placement required an on-the-job created custom solution.

After prepping all surfaces, technicians placed backer rods at the joints' bottoms. Joints were then filled with Dex-O-Tex Cheminert SC Membrane. To mitigate reflective cracking, technicians applied bond breaker tape to the transition area between the new membrane upper surface and structural concrete slab. The cold joint was then topped with a layer of Dex-O-Tex Cheminert SC Membrane inlaid with Dex-O-Tex RP fabric.

Crews next installed Dex-O-Tex Resistite, a cementitious protection coating, on the deck area, avoiding the control joints. A smooth surface was attained by placing a thin coat of Dex-O-Tex Cheminert SC membrane over the cold joints until they were flush with the protection coating's upper surface. Finally, the entire deck was top coated with two layers of AJ-44 Acrylic Topcoat.
